DEPARTMENT OF TRANSPORTATION**DIVISION OF ENGINEERING SERVICES**

Contract #: 04-0120F4Cty: SF/ALA Rte: 80 PM: 13.2/13.9File #: 69.28**WELDING INSPECTION REPORT****Resident Engineer:** Pursell, Gary**Address:** 333 Burma Road**City:** Oakland, CA 94607**Report No:** WIR-006474**Date Inspected:** 29-May-2009**Project Name:** SAS Superstructure**OSM Arrival Time:** 1845**Prime Contractor:** American Bridge/Fluor Enterprises, a JV**OSM Departure Time:** 645**Contractor:** Zhenhua Port Machinery Company, Ltd (ZPMC), Changxing Island **Location:** Shanghai, China**CWI Name:** See Below**CWI Present:** Yes No**Inspected CWI report:** Yes No N/A**Rod Oven in Use:** Yes No N/A**Electrode to specification:** Yes No N/A**Weld Procedures Followed:** Yes No N/A**Qualified Welders:** Yes No N/A**Verified Joint Fit-up:** Yes No N/A**Approved Drawings:** Yes No N/A**Approved WPS:** Yes No N/A**Delayed / Cancelled:** Yes No N/A**Bridge No:** 34-0006**Component:** OBG Fabrication**Summary of Items Observed:**

OBG Bay 6

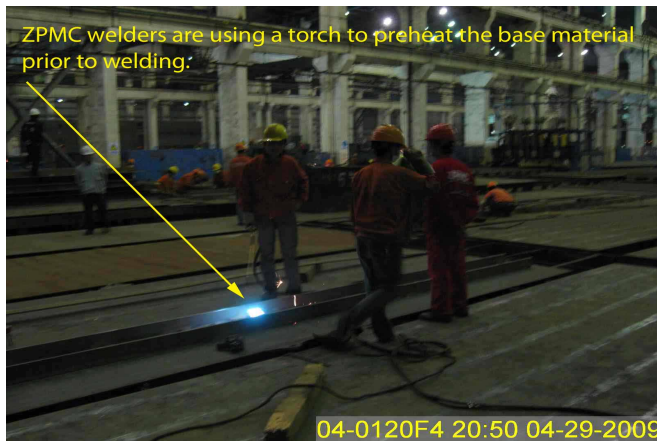
The QA Inspector observed ZPMC welder Mr. Hong Hongbo, stencil 203206 is using shielded metal arc process WPS-B-P-2112 to make fillet tack welds on OBG side plate stiffener weld Base Plate BP206-012-001. The QA Inspector observed a welding current of approximately 170 amps and the base material is being preheated by a torch prior to welding. Items observed by the QA Inspector appear to comply with project specifications.
